Attached for your review is MBTA Safety's Final Incident Report #A15-367. This involved an unintended train movement at Braintree Station on the Red Line on December 10, 2015.

MBTA Safety Department Report No. <u>A15-367</u> Preliminary Report __ Final Report <u>X</u> Date: February 26, 2016

GENERAL INFORMATION Incident Classification: Unacceptable Hazard Incident Description: Near Miss - Unattended Red Line Train Movement Line: Red Line, **Date of Event**: 12/10/2015 **Time**: 6:08 AM **Location**: Braintree Crossover Braintree Branch **Weather Conditions: Operator**: Temp: 45° F David Vazquez Route: #933, northbound Wind: 3 mph Cloudy Witnesses: **Instruction Department DPU Report** #: 3787 **Determination**: 50 passengers onboard **Industry Safe** #: FY15-4830 Train #1502 N/A **Safety Investigator**: Ronald W. Nickle **Re-instruction**: Discipline: Chief Safety Officer N/A Yes 857-321-3255 rnickle@mbta.com INJURY AND FATALITY INFORMATION

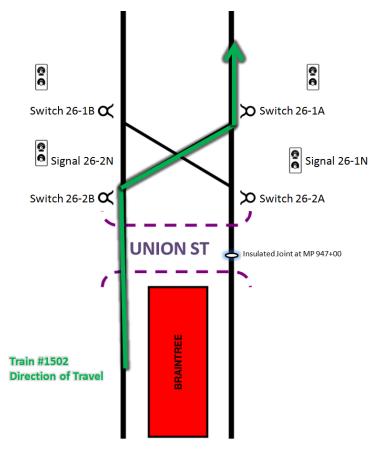
Track and Signals Diagram

- 1. At Signal 26-1N/Switch 26-1A, track conditions were found to be within MBTA Track Standards. However the following defects (determined non-contributory to the incident) were identified and resolved:

- b. Ties and tie plates were within track standards; however as an additional enhancement the track department has scheduled replacement.
- 2. At Switch 26-2A, track conditions were found to be within MBTA Track Standards. However the following defect (determined non-contributory to the incident) was identified and resolved:

- a. An insulated joint in proximity to the switch (MP 947+00) was found to be deteriorated and recommended for replacement. Prior to replacement, this insulated joint was tested by the Signal Department and was found to be within continuity and design limits. There is no indication that the insulated joint contributed to the intermittent code failures.

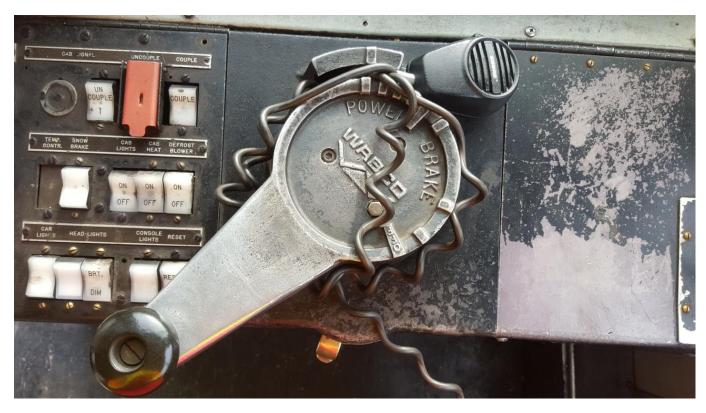
The probable cause of the incident resulted from the tampering with the deadman feature of the cineston in the control cab of Vehicle #1502. The method to inhibit the deadman was the use of the cab's PA microphone cord that was wrapped around the cineston control dial with the cord set between the dial and base plate indicator, with the cineston control set to the full propulsion mode. When the emergency bypass switch was activated, the train entered propulsion mode due to the tampered deadman feature. The train protection design in this mode restricts or limits propulsion to no greater than 25 MPH.

Figure 1. Cineston handle wrapped 2x's as described by responding personnel and customers with the dead-man feature activated (above view)

- 5. Determine the feasibility and cost/benefit, with consideration of vehicle age and replacement schedule, of redesigning and/or reconfiguring the cineston handle to remove, eliminate, or reduce the likelihood of tampering with, inhibiting, or disabling the deadman feature.

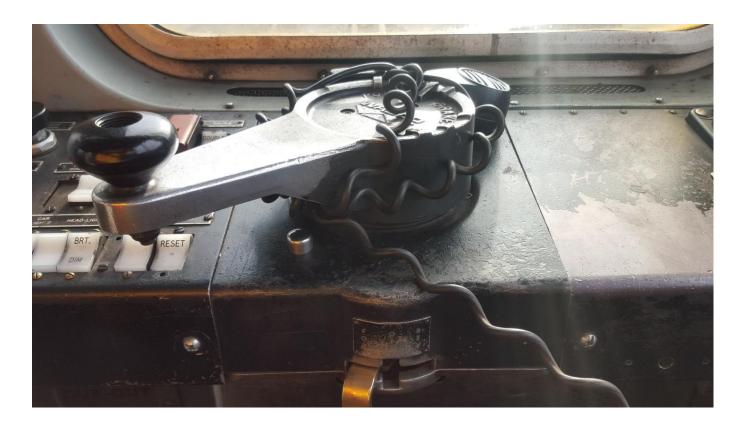
Figure 2. Cineston wrapped two times as described by responding personnel and customers with the dead-man feature activated (MP view). This is a recreation based on descriptions provided.

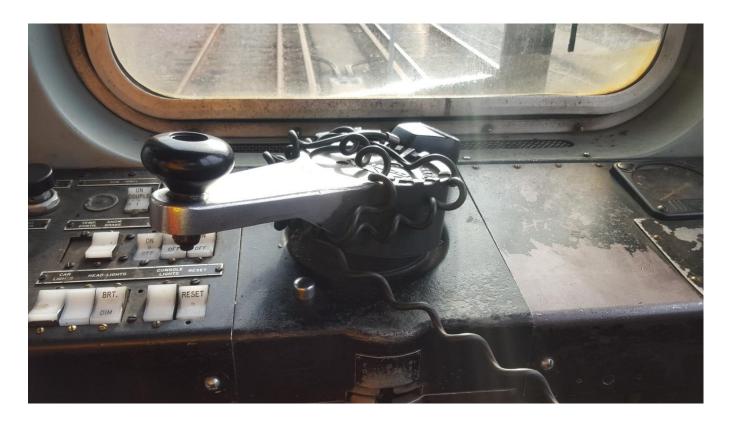
Figure 3. Cineston wrapped 2x's dead-man feature deactivated (MP view). This is a recreation based on descriptions provided.

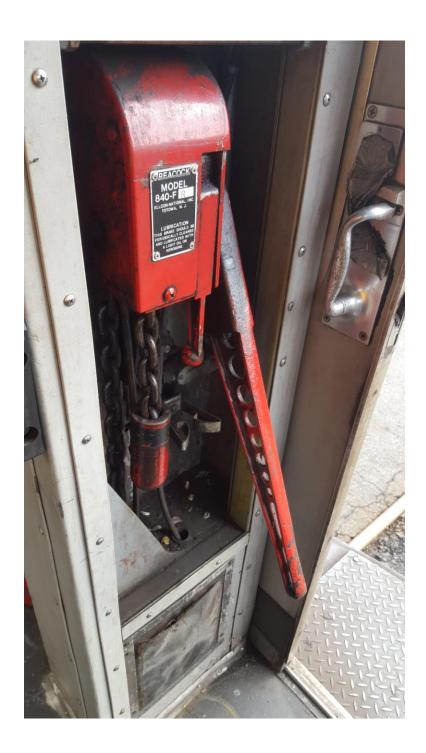
Figure 4. Red Line 1500 In-Cab Handbrake

- 1. A contributory cause of the incident was the failure to apply the handbrake on Vehicle #1502 before exiting the control cab pursuant to operational procedures. The train's ATP safety design restricts train propulsion with the hand brake applied.
- 2. The design configuration placement of the emergency bypass switch, on the outside of the cab, requires an unattended train condition during the duration of the procedure.
- 3. The design configuration of the cineston is such that tampering with or inhibiting the deadman feature can occur using readily available means or methods.
- 4. Prohibited tampering with a cineston is difficult to observe due to sight limitations between stations in the subway environment and location of the cineston below the window level of

- 3. Review, examine, and improve existing emergency bypass and handbrake procedures to eliminate ineffectual steps or redundancies.
- 4. Determine the feasibility and cost/benefit, with consideration of vehicle age and replacement schedule, of suitable technologies, such as CCTV monitoring, to continuously observe an operator's safety activities, safety performance, and adherence to safety critical rules and procedures, including whether the operator is engaged in any prohibited acts.
